OSPITAL Pumping Harding.

Medfield, Massachusetts

Conceptual Planning & Design Report

April 2017

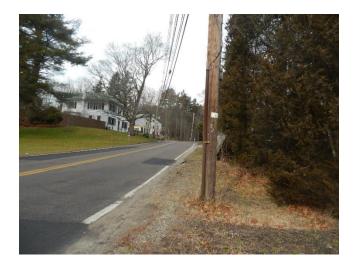
Photograph 1. View from crossing looking northwesterly along Harding Street.

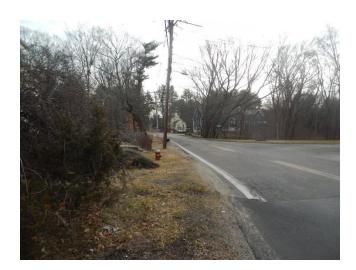
Photograph 2. View from crossing looking southeasterly along Harding Street. Shrubs beyond hydrant may reduce the view in full-leaf conditions.

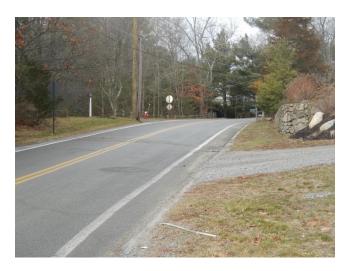
Photograph 3. View from crossing looking westerly along Farm Street.

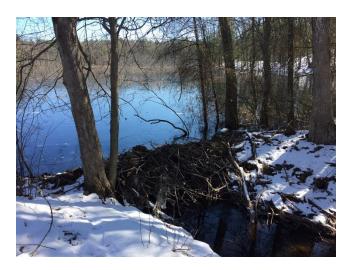
Wetland and stream locations were generally consistent with MassGIS with the exception of the wetland system located to the northeast of Harding Street. MassGIS depicts Bordering Vegetated Wetland (BVW) on both sides of the tracks with two hydrologic connections that traverse beneath the rail bed. The areas of BVW are generally consistent with MassGIS depictions, however the northern hydrologic connection was not observed in the field. Rather, the two wetland systems on the east side of the rail bed are connected via a well-defined stream channel that runs parallel to the rail bed and flows in a southerly direction. At the time of the site visit, the outlet from the northern section of BVW had been apparently dammed by beavers causing ponding within the BVW and significantly reducing flow within the channel.

Photograph 5. View of beaver dam and beginning of stream channel at southern extent of BVW, east of rail bed.

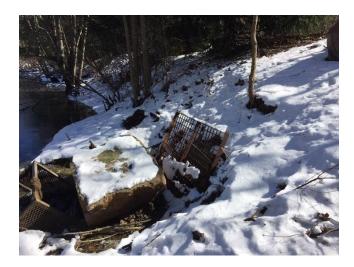
The southern hydrologic connection is present as depicted by MassGIS and consists of a stone box culvert located beneath the rail bed. A large stone block, grate, and cage device was observed on the western end of the box culvert that may have been installed to prevent beaver passage.

Photograph 6. View of western end of box culvert with apparent beaver device.

The stone box culvert located at Station 831+52 (250+/- feet north of Harding Street) appears to be compromised by metal grates and a granite block. The flow through the structure may be impeded by the material. It is recommended that this structure be repaired to maintain the intended flow through the structure.

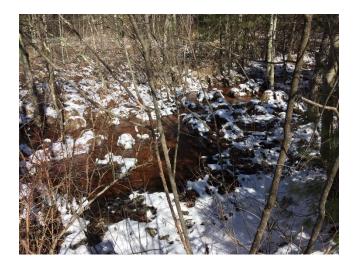
Photograph 7. View of BVW containing red maple saplings and vegetated hummocks.

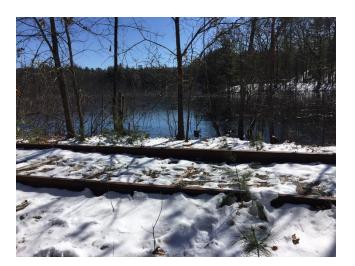
Photograph 8. Looking east across railroad tracks at area of open water above beaver dam.
